NATIONAL NEWS

OCTOBER 1983

THE INCIDENT.

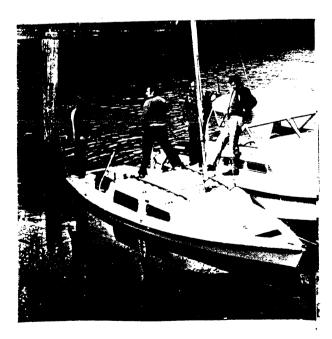
Photo No. 2 shows same situation as photo 1. except that plate completely housed. Neutral self righting.

Photo No.3 shows hull swamped by pumping in water to overflow point. With two crew on board, hull buoyant but only just - unstable in upright position, Boat in normal sailing trim, bunk cushions left onboard. No extra buoyancy installed.
